New Payment Instructions

BMW 5HP24

Buzzing or Droning Noise from Bellhousing Area

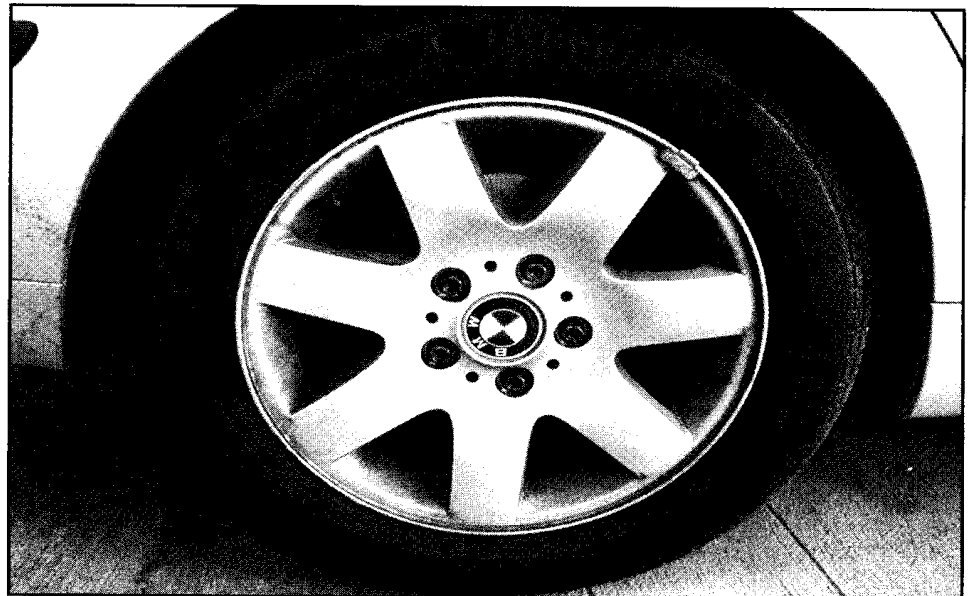
Curve-recognition programs in BMW's 3, 5 and 7 series with bald tires can make your head go even balder. The purpose of this strategy is to prevent shift business during turns for driver pleasability. Recently we had a call where a shop was distraught over a 530i with a 5HP18 that had no upshifts to 4th or 5th under light to medium throttle and no upshift to 3rd under heavy throttle. Much was done and replaced to remedy this complaint when all along it was one tire being a different size from the other three.

Now you might ask yourself, how could that be? Well, this car owner had three worn tires and a new spare. The tread on the new spare made this one tire significantly larger than the other three worn tires. This tire-size difference was enough to initiate the curve-recognition program while the vehicle was driving straight, resulting in no upshift to 3rd, 4th or 5th depending upon throttle opening. In fact, we have had complaints of no upshifts or late upshifts into 4th or 5th after kick-down on 7 series and 2nd-gear starts and no 4th on 3 and 5 series with the 4L30-E transmission. In other words, depending upon the severity of tire-size differences due to wear, underinflation, overinflation or several different tire sizes combined, the result could be a respectable variety of complaints of no or late upshifts – it's enough to make you go bald!

Now, if you have a scan tool that provides you with data stream which presents the Curve Recognition PID, if you see this PID display "activated" while driving straight, you may keep a few hairs on your head and fix the problem without emptying your wallet on computers, speed sensors or throttle-position sensors. If you do not have data-stream info but you have a scan tool that does not report any codes, look at those tires!

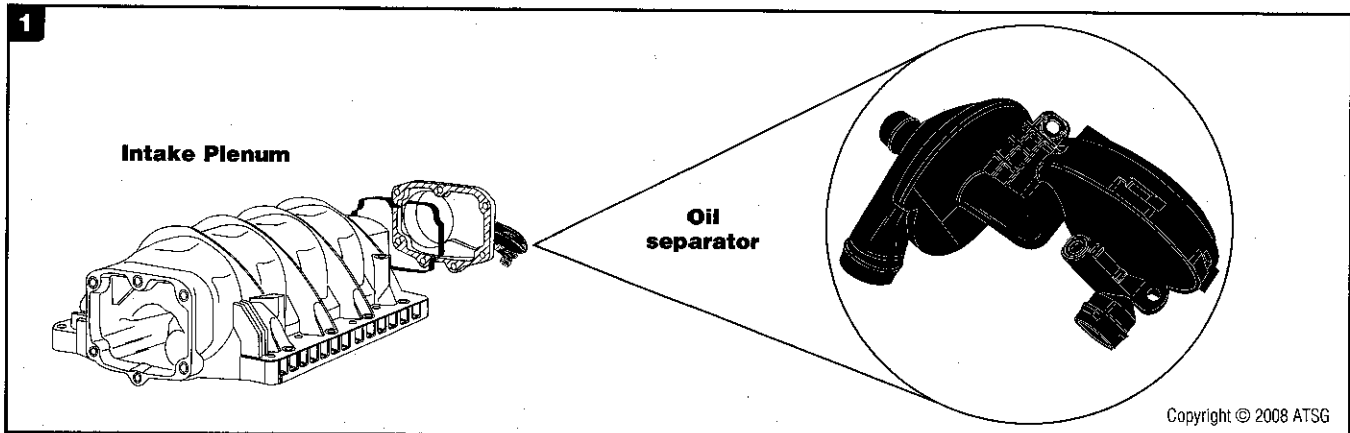
Some V-8 BMW models equipped with the ZF 5HP24 transmission may exhibit a buzzing or droning noise coming from the bellhousing area of the transmission. This noise may sound like a pressure imbalance from the volume-control valve in the pump or may even sound like a torque converter that is about to fail.

The cause of this problem is typically a valve resonance coming from the oil separator, which is situated at the back of the intake plenum, right above the bell-

housing. It can be compared with the noise we have had on the 4EAT in the Ford Escort with a dirty PCV valve. Testing: To verify whether this is the problem with this vehicle, start the engine and wait for the noise to start, remove the oil filler cap and see whether the resonance goes away. If it does, you will need to replace the oil separator.

To correct this condition refer to Figure 1 to locate the oil separator and replace it. Because of the part-number differences for the different models, you will need to contact your local dealer for the replacement-part number. **TD**
